Preliminary Summary Report

Re: Stephanie Wadsworth & Matthew Wadsworth v. Walmart, Inc & Jetson Electric

Location of Loss: 1620 HWY 374, Green River, WY

Service Requested: Case Review/ Computer Fire Modeling and Fire Dynamics Review

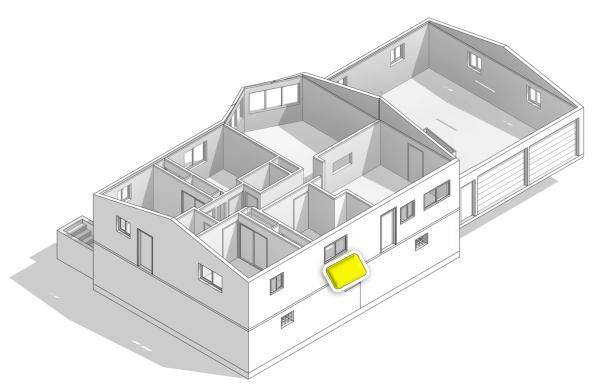
Figure 4: 3D Building Information Modeling (BIM) from Matterport 3D scan (Dimensions are in the BIM file; note: the yellow box indicates the location of the smoker's shed).

Ventilation openings (e.g., doors and windows) are essential to evaluating fire dynamics within a structure and govern much of the physics of fire growth and spread during the fire. Each room's dimensions and ventilation openings were captured through the Matterport 3D scan and Matterport building information modeling (BIM) file (Figure 4).

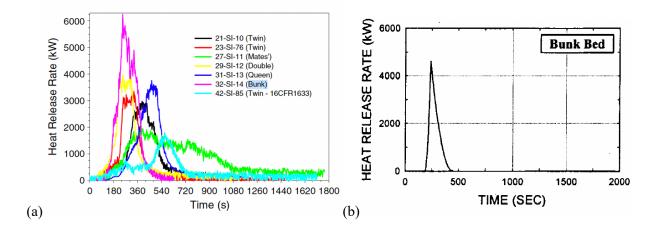
Figure 6: Heat release rates of bunk beds (a) Bwyala study, (b) Kim study

heat release rate of 7695-18,126 kW if all the wood paneling were ignited and burned. A bunk bed was also located along the east wall of the bedroom near the window, which would contribute approximately 4,800-6,250kW and would reach this peak in approximately 200-300s (Figure 6).^{18, 19} A hoverboard was located along the north wall of the bedroom near the closet door. The hoverboard would have approximately a peak heat release of ~500kW and reach this peak in less than 20-30 seconds based on flame heights during actual fires captured by videos of similar hoverboards burning. Combining the wood paneling, hoverboard, and bunk bed could produce peak heat release rates of 12,995-24,876kW.

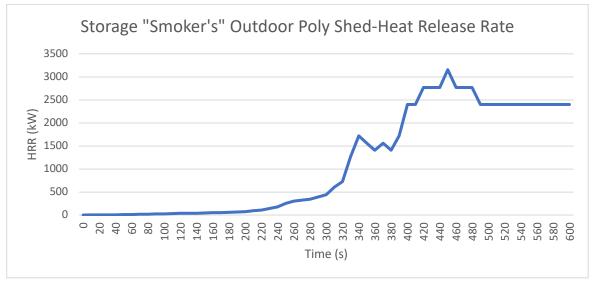
Figure 7: Heat Release Rate for Outdoor Storage Shed (based on fire test data)

end table in the southeast corner, a metal chair in the southwest corner, and a comforter/blanket (Figure 8).²¹ Based on the fire test of the shed, the peak heat release rate was approximately 3,000-5,000 kW, which reached this peak in approximately 400-450 seconds, assuming a flaming ignition of the comforter (Figure 7). This fire could have smoldered before transitioning into flaming combustion due to the type of fuels and potential ignition sources. Research has been conducted on the length of time it takes for a cigarette to transition from smoldering to flaming combustion, which states "this transition from smoldering to flaming does not occur in all cases; when it does, times from placement of the cigarette to flaming of *22 minutes to several hours* have been reported".²² Flame heights exceeded 20 feet (6.1m).

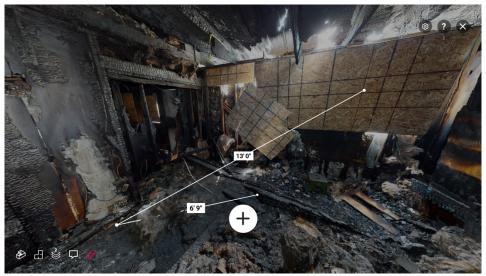
Figure 17: Matterport scan with dimensions from hoverboard location to the corner of the bunk bed (\sim 6.75 ft) and the window (\sim 13 ft).

All early eyewitnesses mentioned the window and wall behind the bunk bed in bedroom #4, located ~13 feet away from the hoverboard, had ignited early in the event and that the bunk bed had not.⁶⁶ The energy required to ignite the wall behind the bed and cause the window to fail ~13 ft from the hoverboard was assessed (Figure 17).

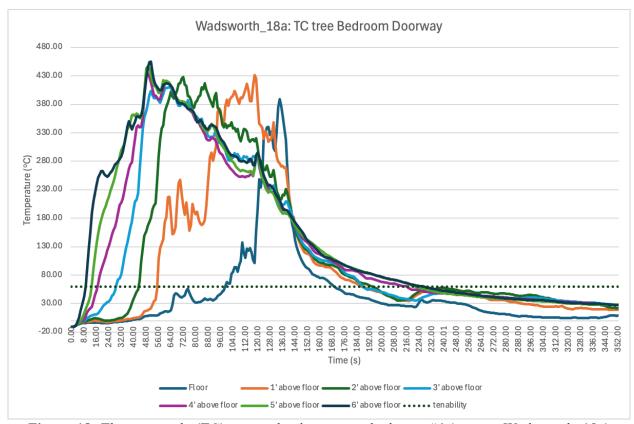
Figure 18: Thermocouple (TC) tree at the doorway to bedroom #4 (source: Wadsworth_18a)

A fire originating at the hoverboard quickly creates temperatures above the tenability criteria for bedroom #4 doorway to the hallway. The temperature criteria were exceeded at the bedroom doorway for both the 6 ft and 3 ft heights within 5-49 seconds. See Figure 18 as a representative example of the temperature data for a thermocouple tree (temperatures at 1-ft intervals from the floor) in the bedroom doorway for bedroom #4. The temperature criteria are reached before the window fails, which is inconsistent with the witness statements and their survivability. Therefore, the egress of Layne and Gunner through the bedroom doorway with an origin at the hoverboard is inconsistent with their explanation of the events the night of the fire and the survivability of the occupants.

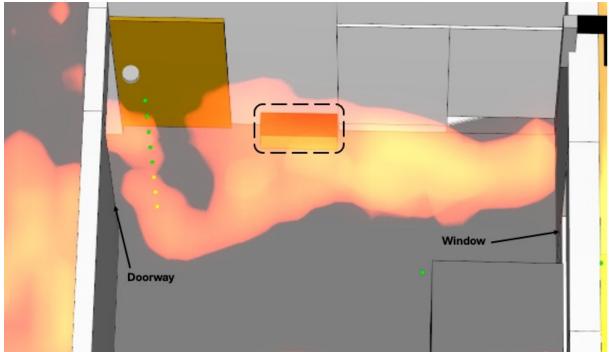
Figure 19: Hoverboard Origin: Bedroom #4 aerial view-location of mixture for flaming combustion within the compartment post-flashover (Note: dashed line is where the hoverboard was located; 130 seconds into the simulation (source: Wadsworth 16))

Most of the flaming combustion remains near the hoverboard in the early stages of the fire until flames spread across the wood paneling lining the wall near the hoverboard and then across the compartment through radiant heat transfer, igniting the bunk bed. When the compartment nears full-room involvement and the window has failed, a flow path extends from the window to the open doorway of bedroom #4 (Figure 19). The ventilation-controlled conditions create a path along the north wall where combustion continues post-flashover. Therefore, the extent of damage along the north wall is consistent with ventilation-generated fire patterns along the flow path from the window to the bedroom doorway (Figures 19-21). The damage and fire patterns identified by the fire investigators near the hoverboard result from this flow path from the window to the doorway and are consistent with ventilation-generated fire patterns, not an origin at the hoverboard.

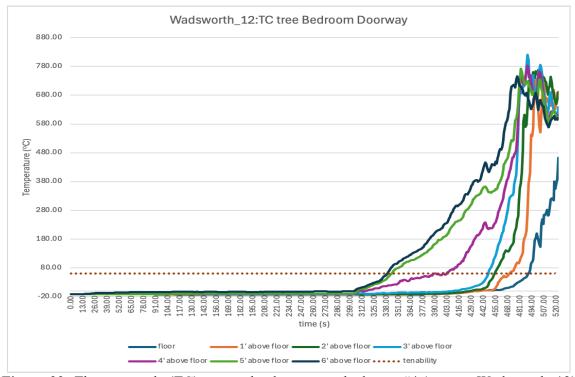
Figure 22: Thermocouple (TC) tree at the doorway to bedroom #4 (source: Wadsworth 12)

The doorway temperature tenability thresholds are met as bedroom #4 transitions to full-room involvement, which only occurs after the window failure and the fire spreads into bedroom #4. See Figure 21 as a representative example of the temperature data for a thermocouple tree (temperatures at 1-ft intervals from the floor) in the bedroom doorway for bedroom #4.

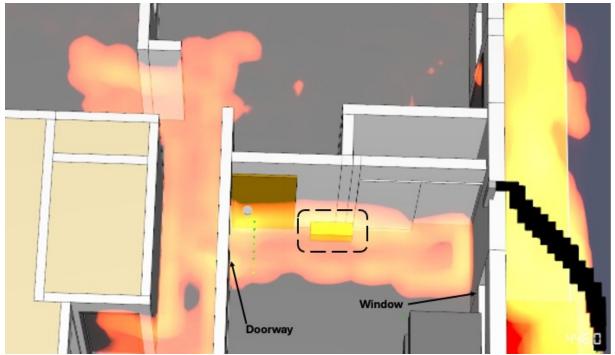
Figure 23: Storage "Smoker's" Shed Origin: Bedroom #4 aerial view-location of mixture for flaming combustion within the compartment post-flashover (Note: dashed line is where the hoverboard was located; 446 seconds into the simulation (source: Wadsworth 12a))

Following the failure of the window and ignition of the bunk bed, most of the combustion remains near the bunk bed and spreads across the compartment through radiant heat transfer and fire spread across the wood paneling. When the compartment nears full room involvement, a flow path extends from the window to the open doorway of bedroom #4 (Figures 23-26). The ventilation-controlled conditions within bedroom #4 create a path along the north wall where combustion continues post-flashover. Therefore, the extent of damage along the north wall is consistent with ventilation-generated fire patterns along the flow path from the window to the bedroom doorway and not an area of origin (Figures 23-26).
